# fort scott

A CULTURAL LANDSCAPE ASSESSMENT

March 2008

Presidio Trust  
**SMWM**

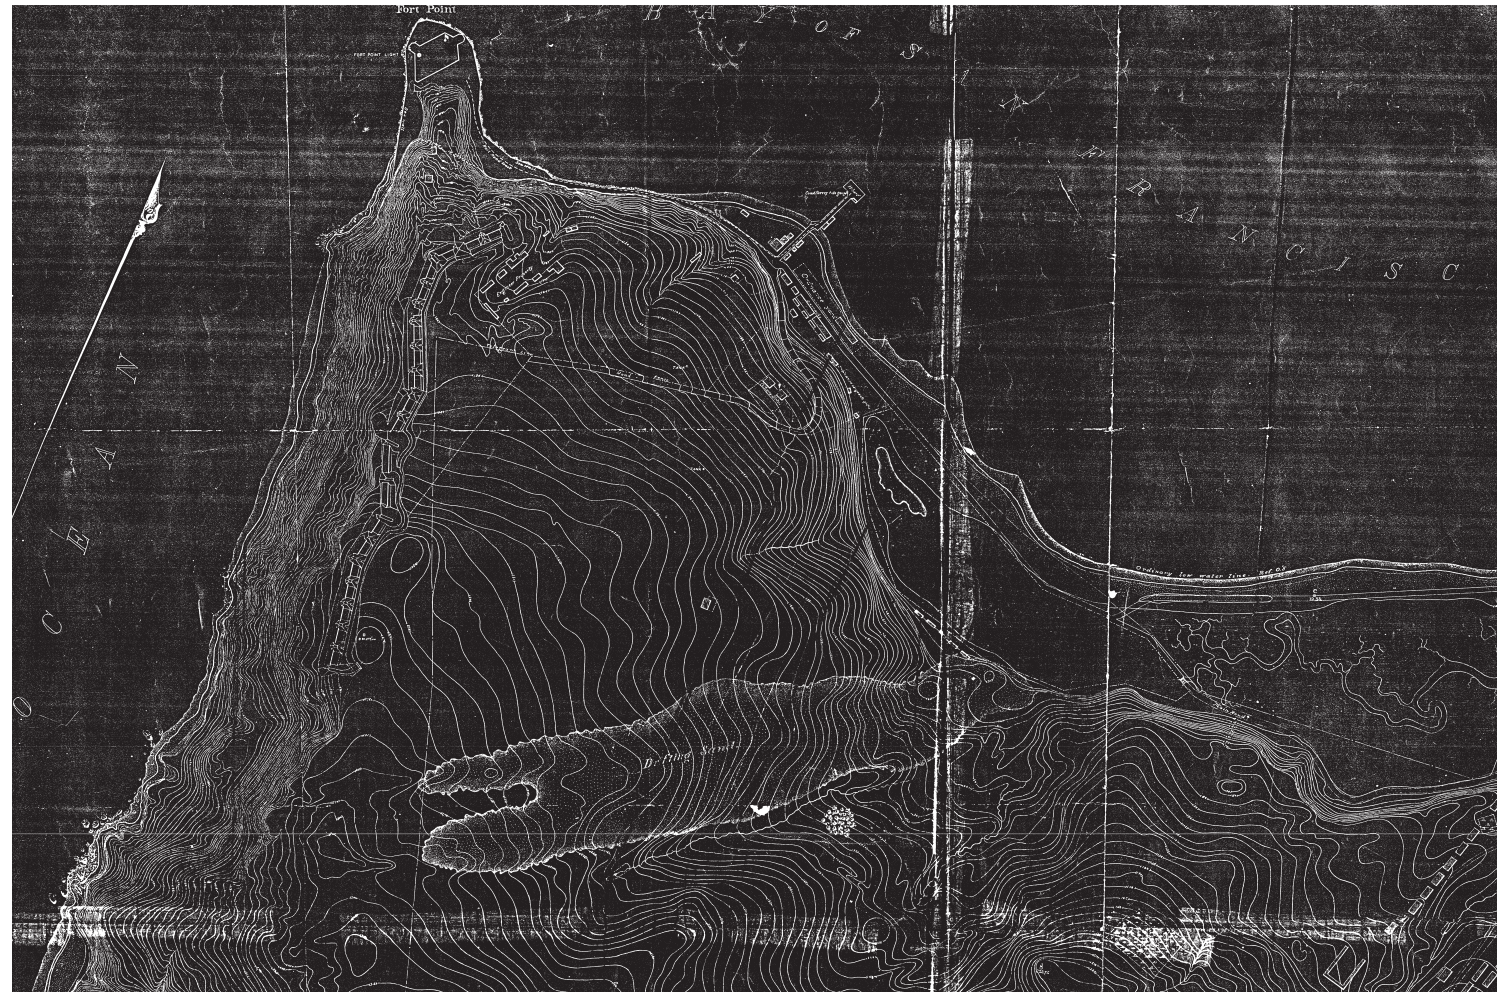
Drifting sands and a creek mark the location of the future Ft. Scott, Willaim Hammond Hall Map of the Presidio, 1871

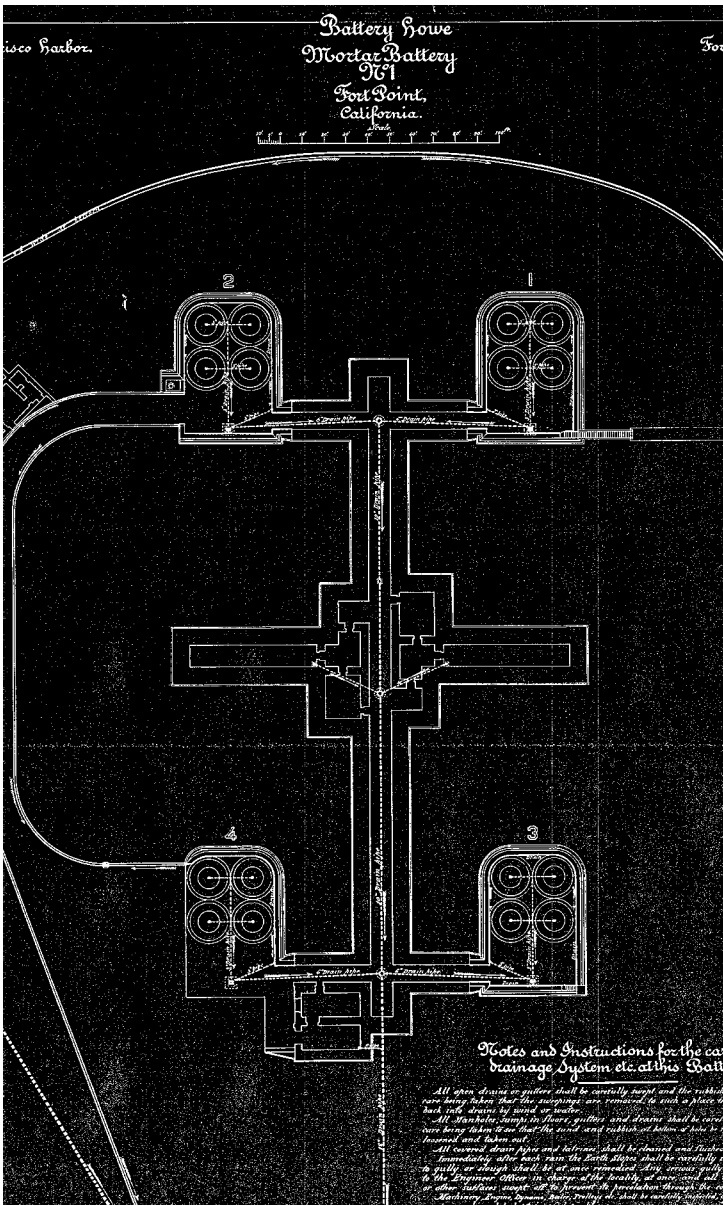
Battery Howe plan, no date .

Construction on Battery Howe (it was renamed Battery Howe-Arthur Wagner in 1902)<sup>3</sup> began in April 1893 and was completed in 1895. The battery’s mortars were put into place in 1895 and had a range of eight miles. The battery was designed to have the capability of “all around fire,” that is its mortars could be rotated 360 degrees, and from this particular location were within range of both the ocean and bay. However, the mortars had a minimum range that required the battery to be placed

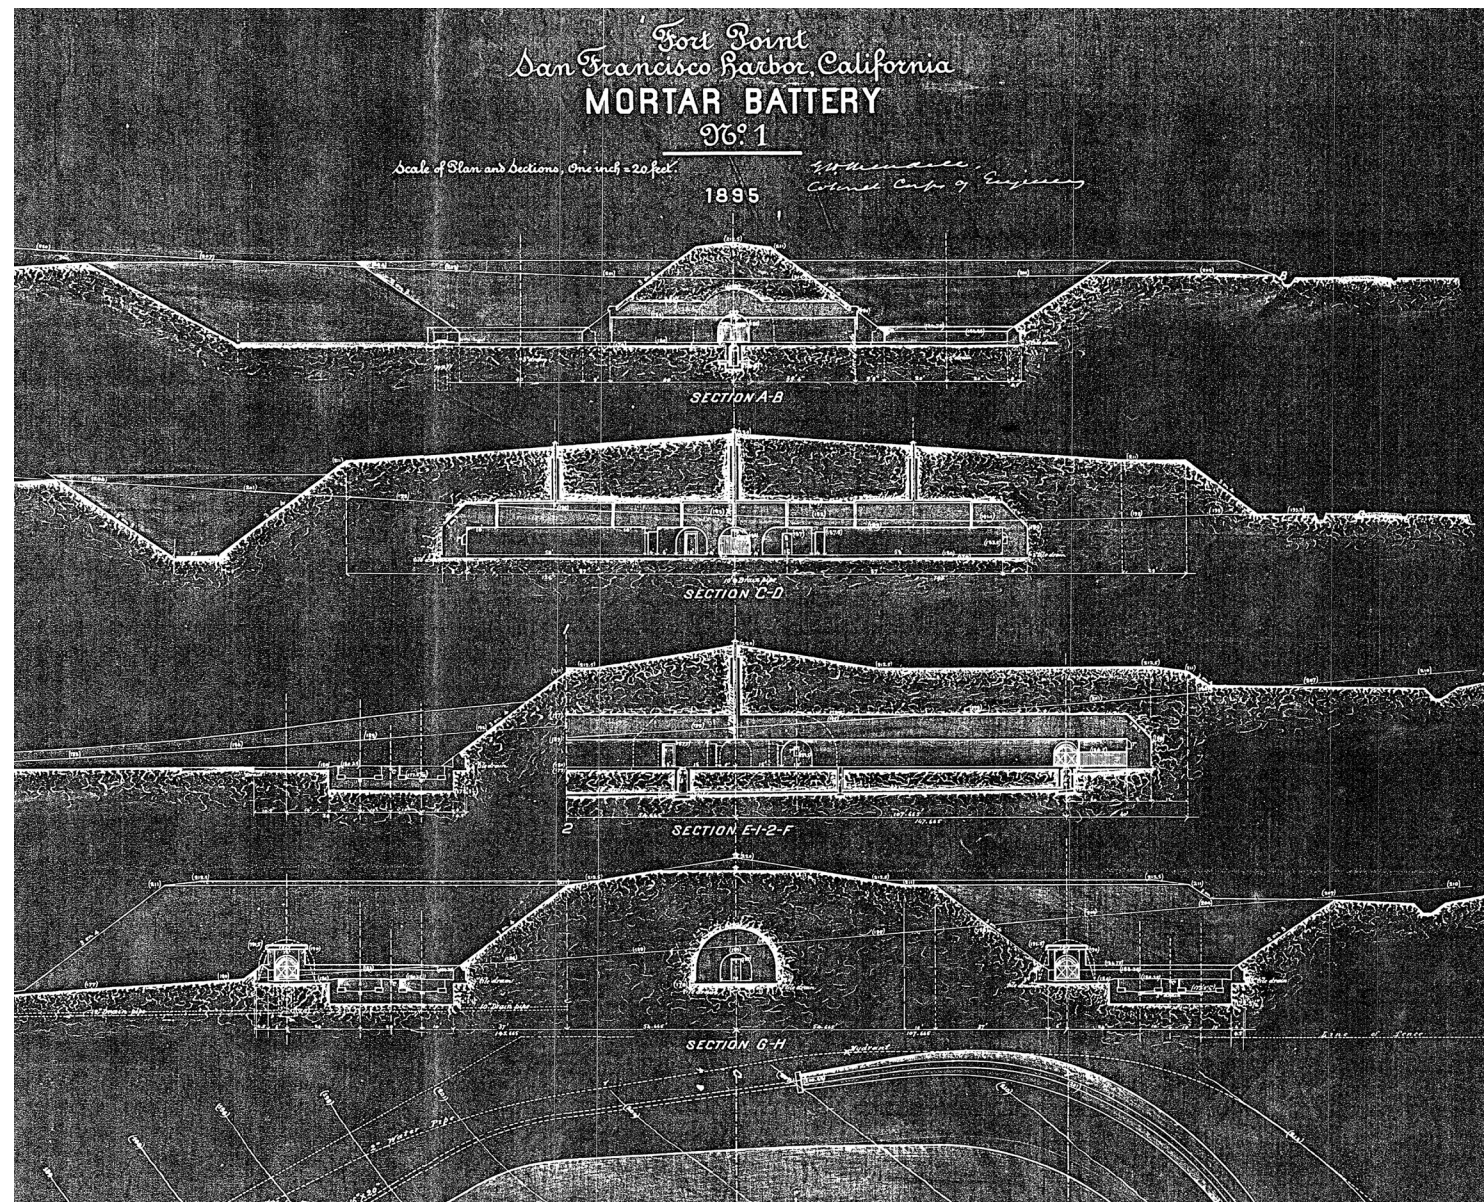
Battery Howe Wagner sections, 1895.

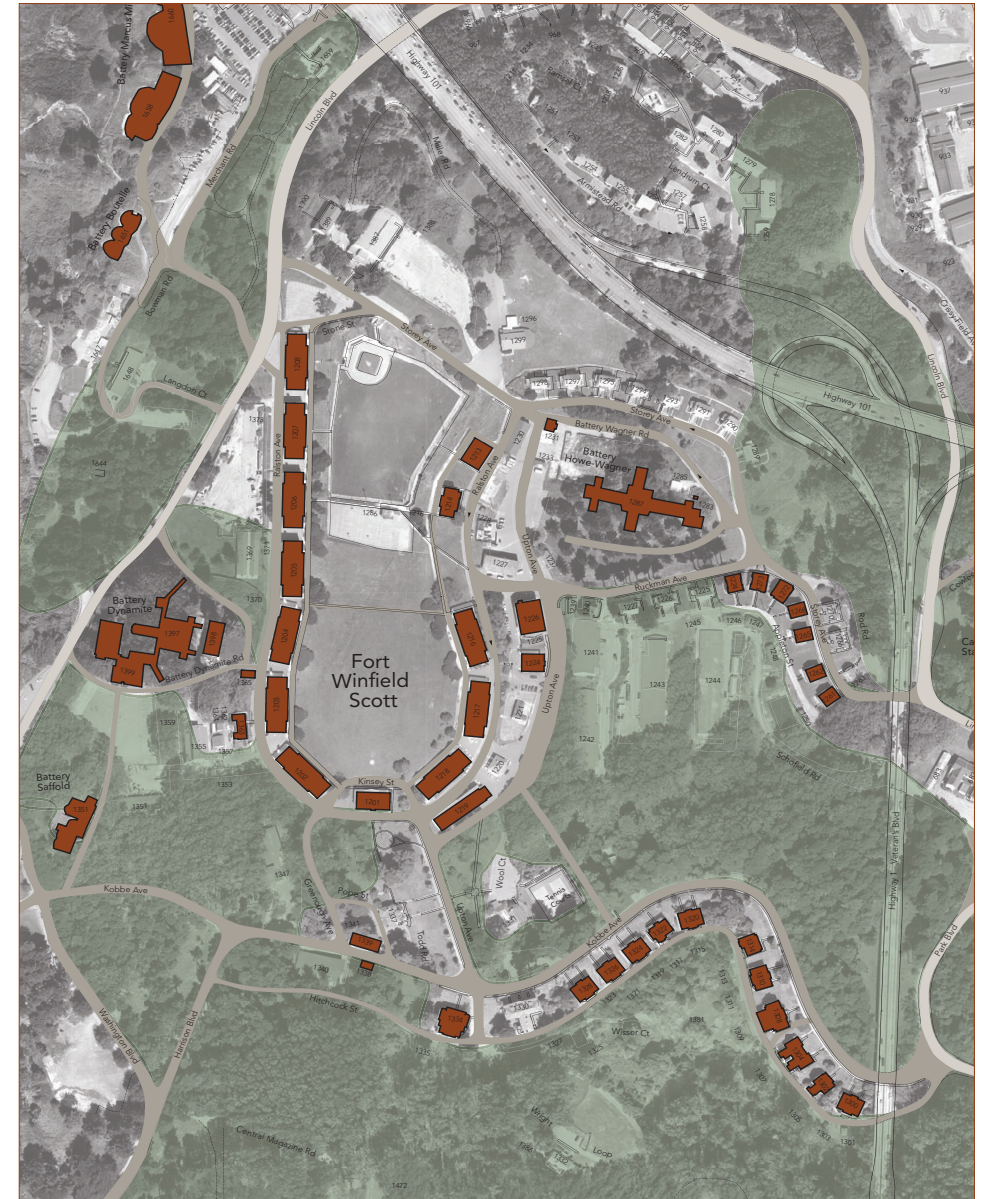
**Plan of Ft. Scott, 1891-1914 development**  
Buildings shown in red were constructed in this time period.

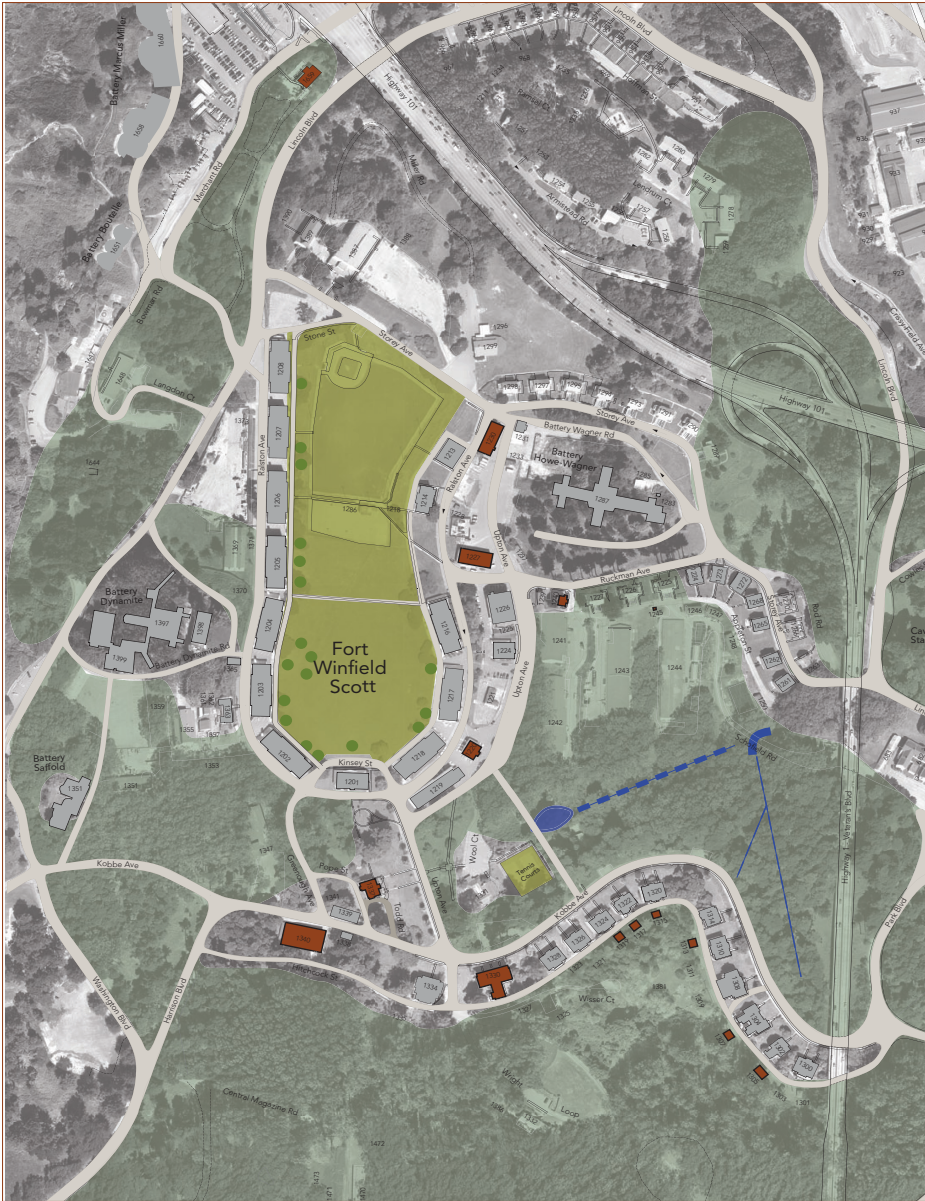
**Plan of Ft. Scott, 1915-1918 development**  
Buildings shown in red were constructed in this time period.

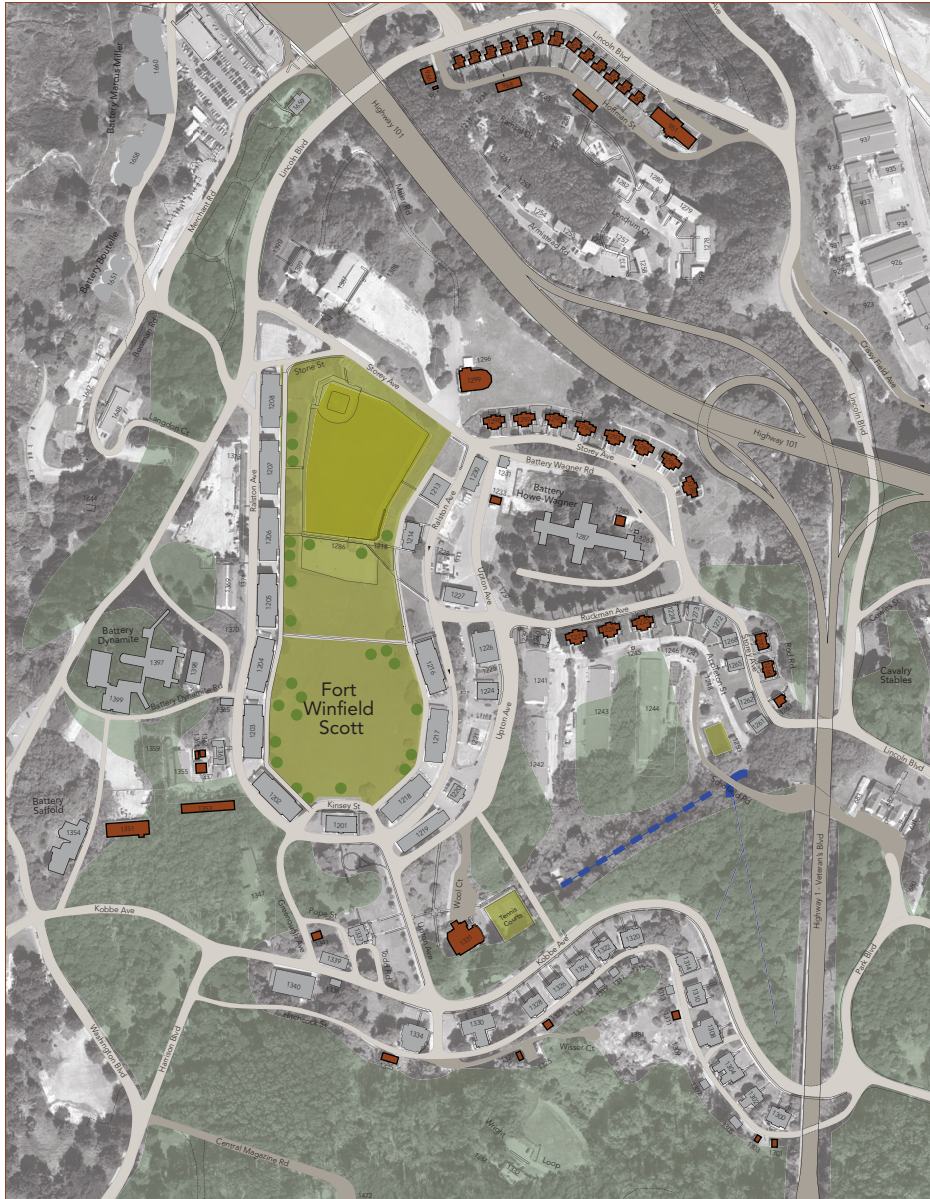
**Plan of Ft. Scott, 1919-1940 development**  
Buildings shown in red were constructed in this time period.

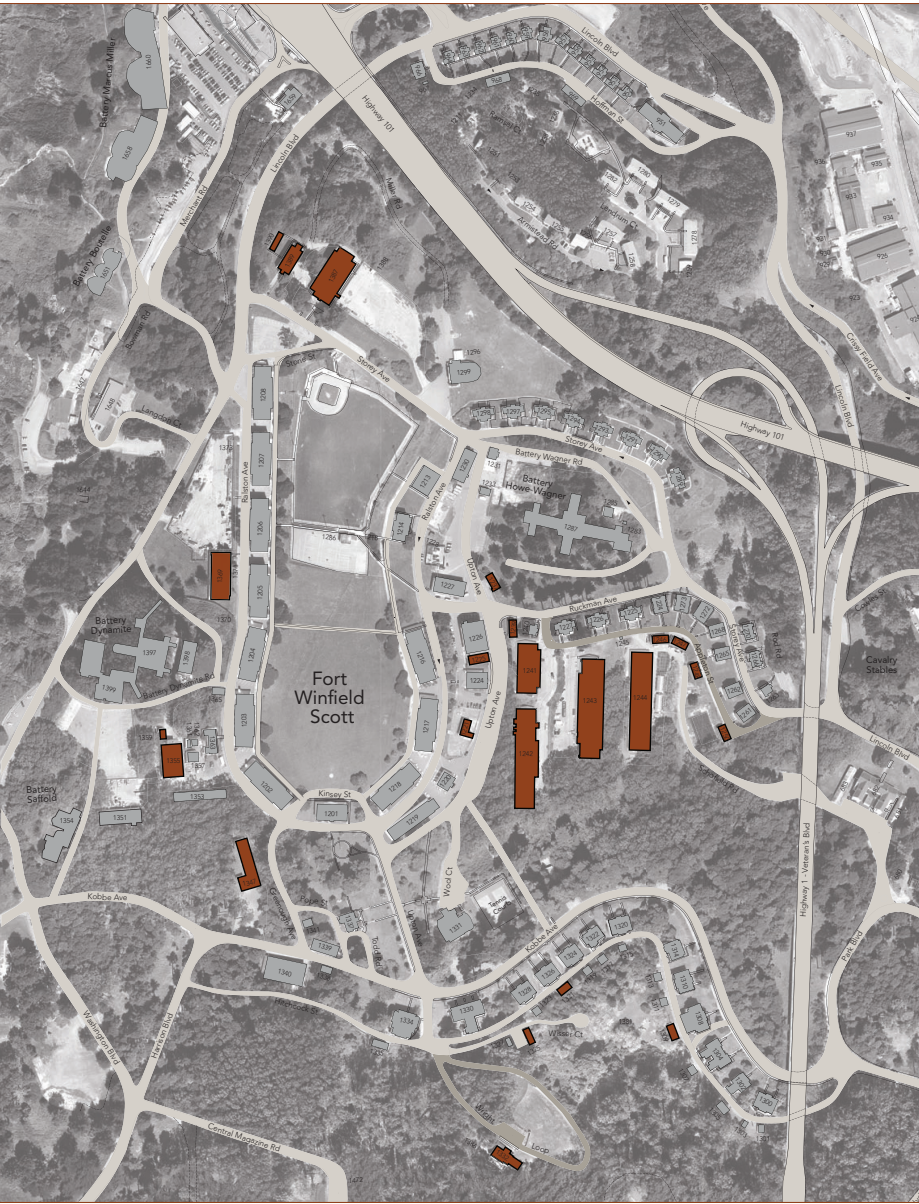
**Plan of Ft. Scott, 1941-1945 development**  
Buildings shown in red were constructed in this time period.

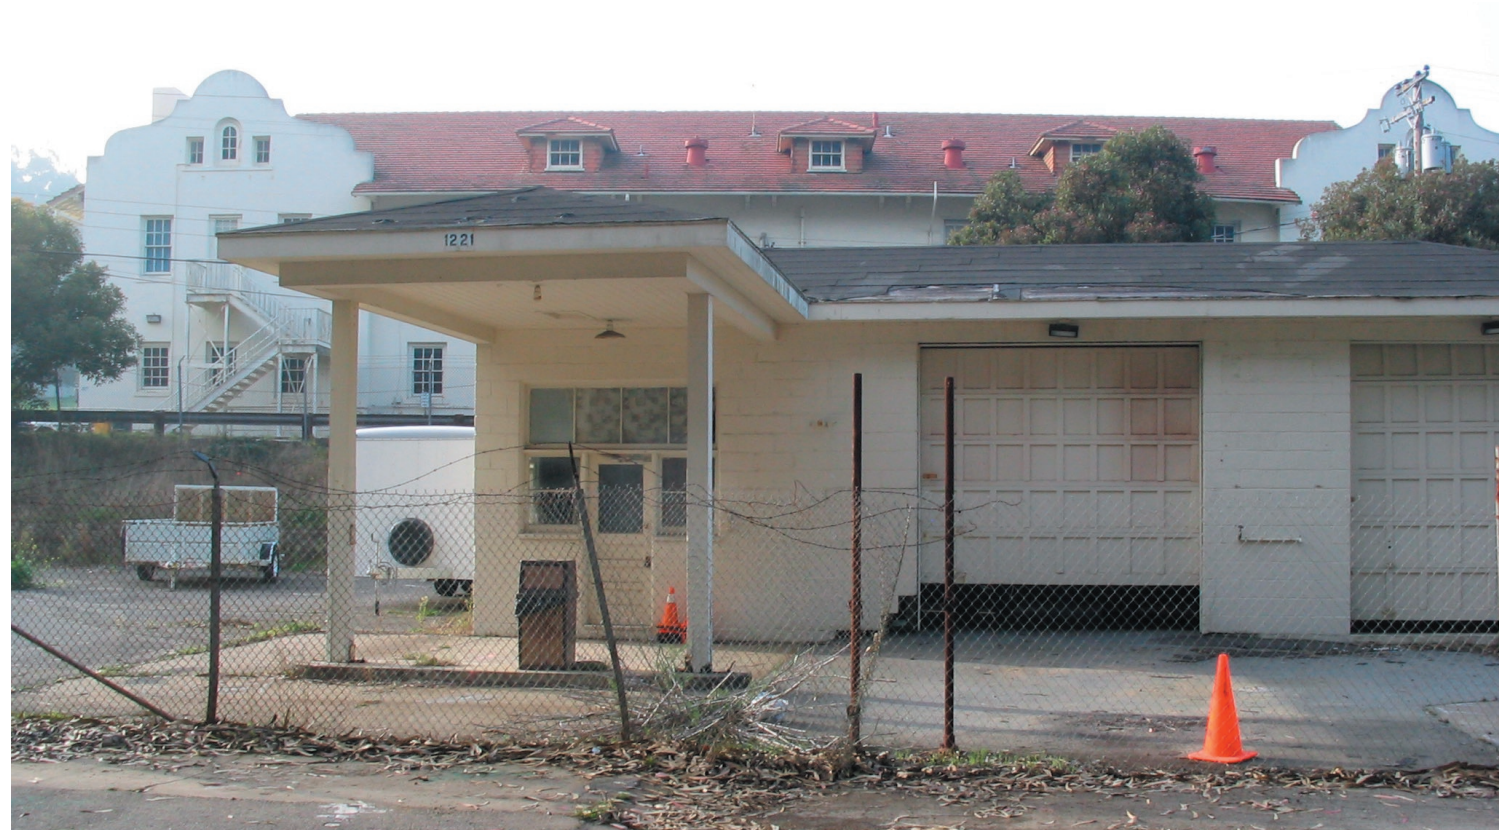
**1.18** Building 1221 adjacent to Parade Ground Area. Haphazard paving, and the addition of incompatible elements such as guardrails and fencing obscure the original character of this service area east of the Parade Ground.

The open concrete gutter around the Parade Ground remains in place although sections of it are covered with dirt (and may be missing).

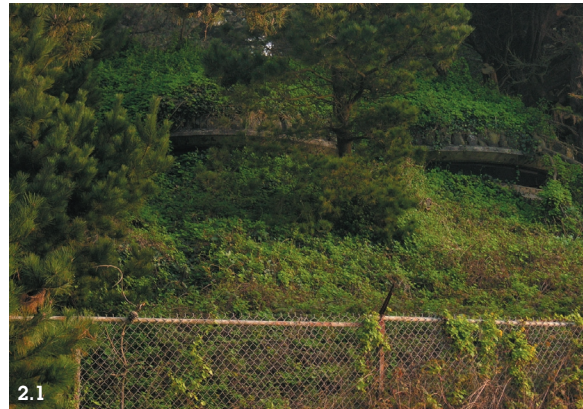
2.1 West side of Battery Dynamite, showing overgrown condition.

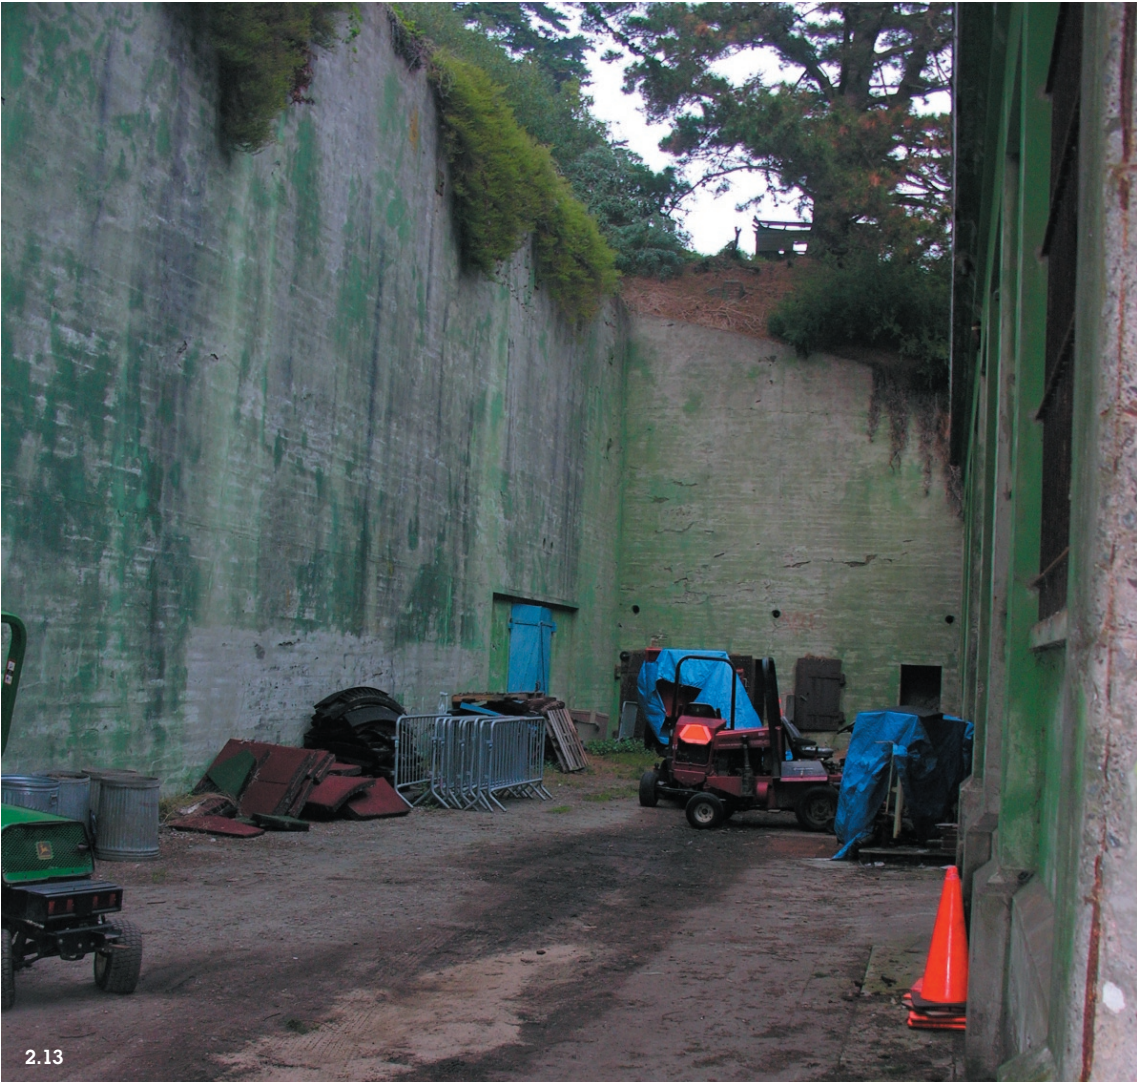
2.13 Battery Dynamite’s impressively scaled concrete walls and strong sense of space are unusual features in comparison to other coastal batteries.

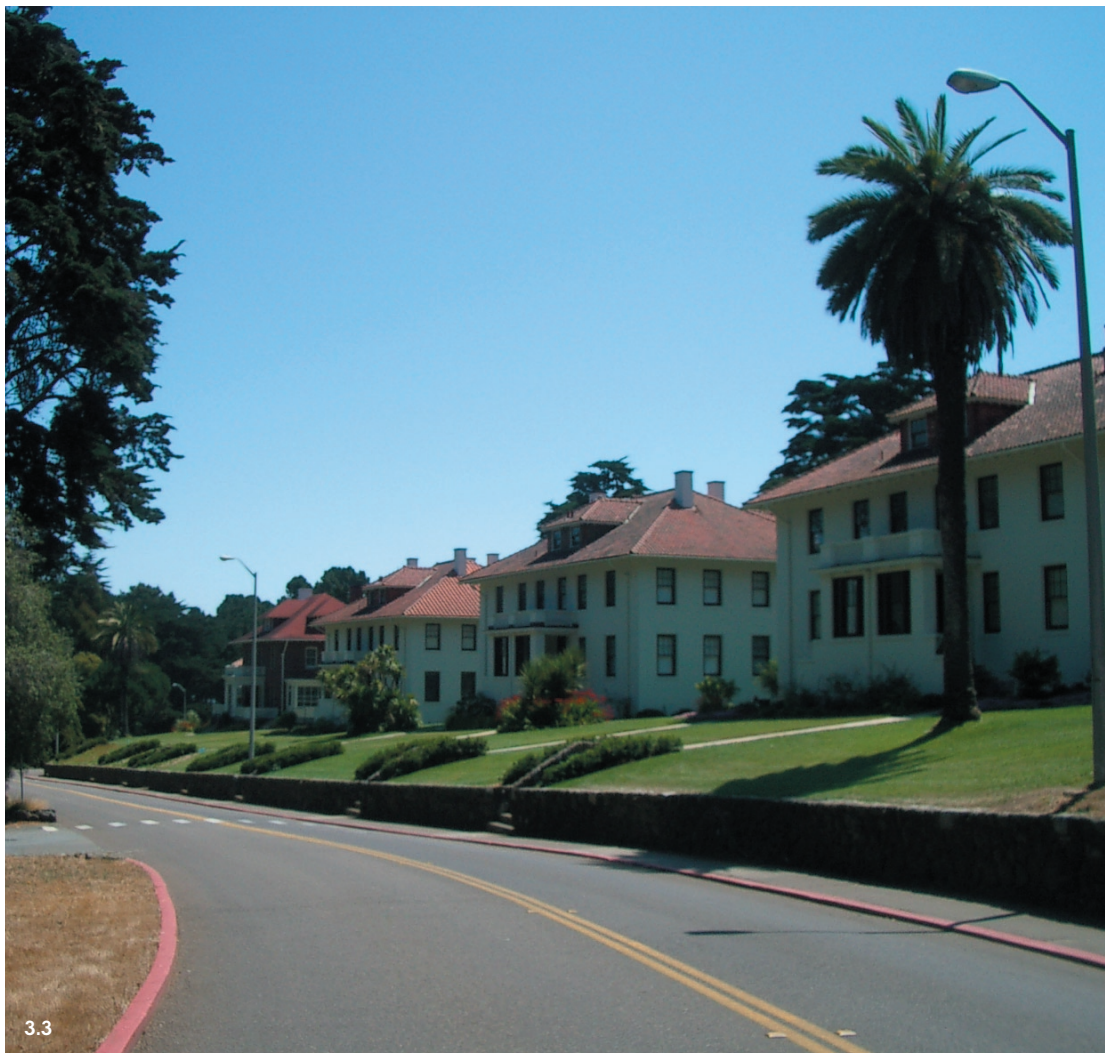
3.3 WPA era walls and entrance stairs along Kobbe.

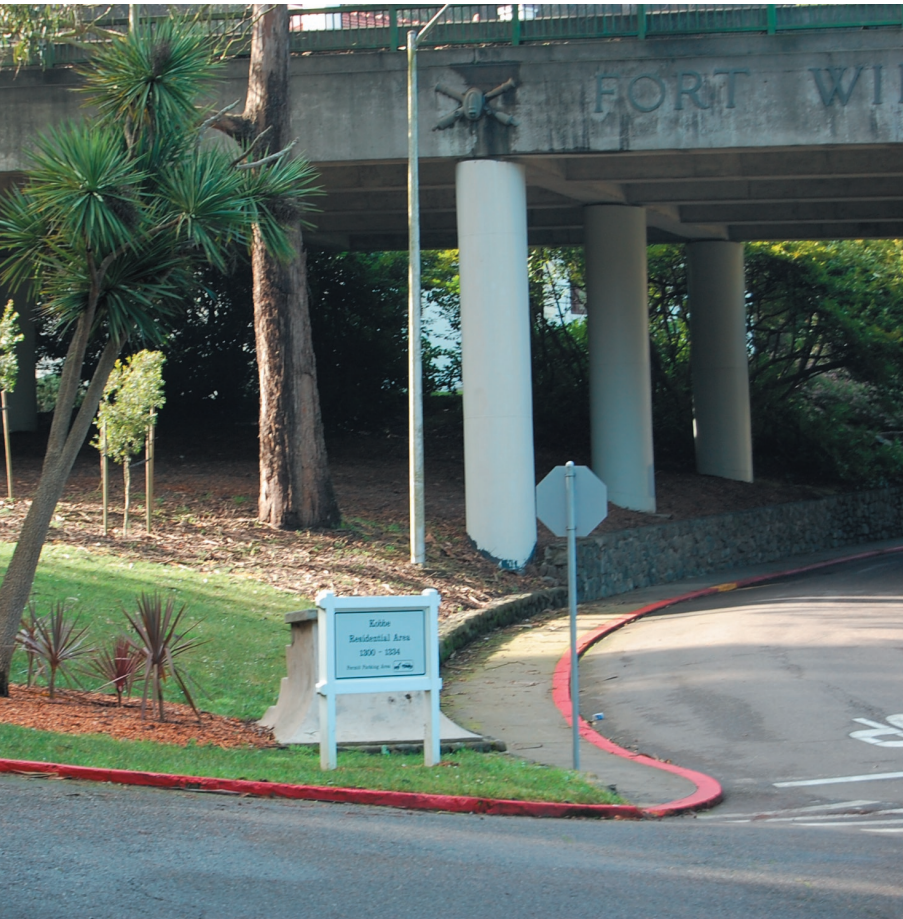
3.15 View of entrance pillars. (Cannons were removed at an unknown date)  
New signs obscure the view of the pillars.
